Behaviour of an electrically regenerated particulate filter system on a wheel loader

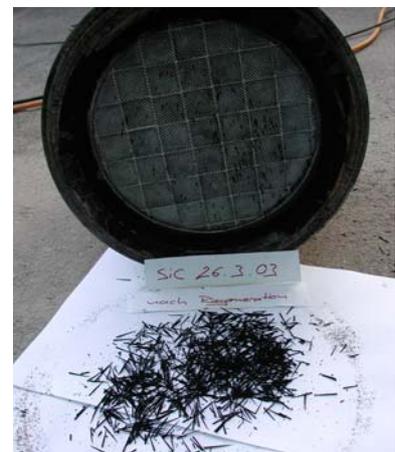
Even after multiple attempts of electrically regenerating the filter, the soot remained in the form of coked bars and tubes within the filter (fig. 1).

Our findings indicate that the soot, produced by this particular engine, is of a composition that is unusually difficult to ignite and hence causes problems with the regeneration. Obviously this filter system was not appropriate for this particular engine under those particular operating conditions. The problem was eventually solved after a careful analysis of the filter regeneration behaviour and the soot composition.

Fig. 1: soot-bars after regeneration ("French fries")

A high powered quick regeneration heating unit was able to provide a temperature sufficient for proper regeneration.

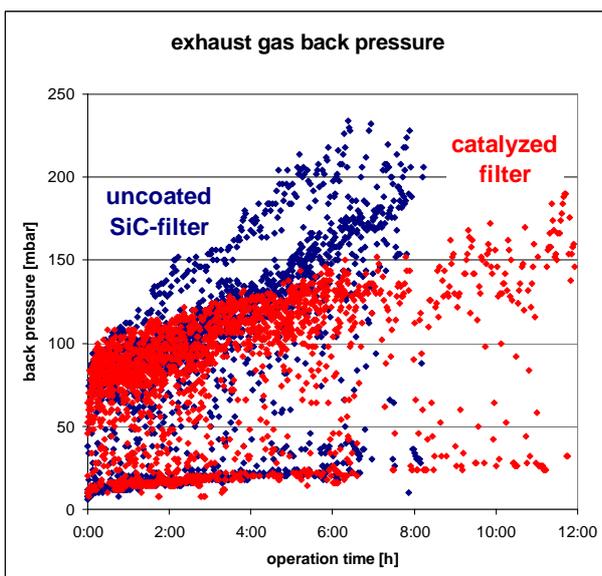
Fig. 2: back pressure maxima values of the two filter systems

Despite a much improved regeneration, the maximum operating time of the wheel loader was still too short for an uninterrupted operation cycle. It was observed, that maximum back pressure was reached before the filter was completely loaded with soot. Apparently the composition of this particular soot forms an unusually dense layer on the surface of the filter. This causes a premature increase in back pressure.

The application of a catalyzed filter instead of an uncoated SiC-Filter, in addition to a thermal insulation of the exhaust pipe, provided sufficient regeneration during operation. As a result, the operation time could be extended to 11 hours (fig. 2).
